Specialization certificate in geological and climate related risk

Seismic Physical Vulnerability of Two Buildings in Asunción - Paraguay

Moisés Alejandro Gadea Villalba

December 2014

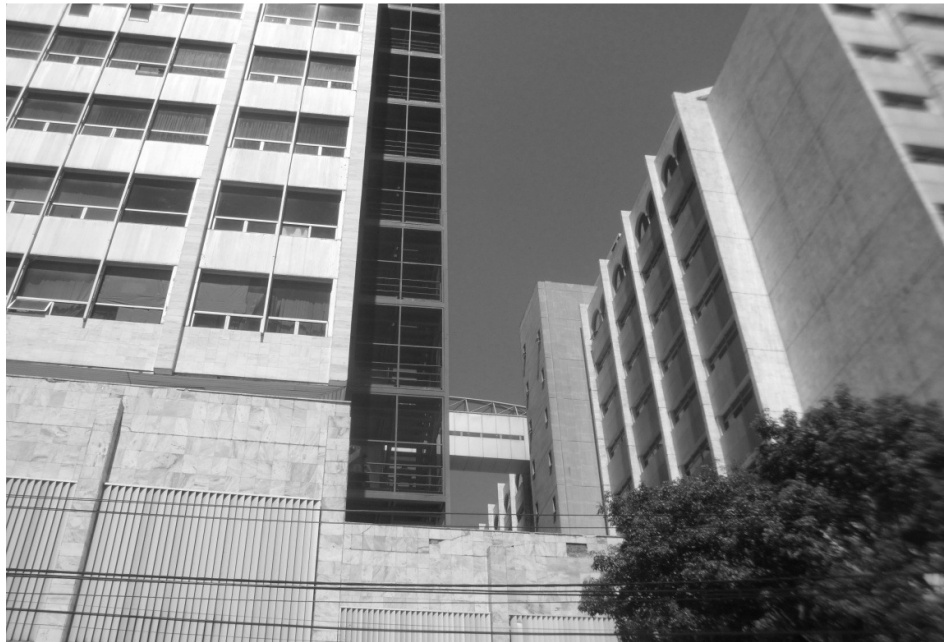
Fig. 2

Twin tower set of buildings. The left tower was built in 1982 and the right in 1996.

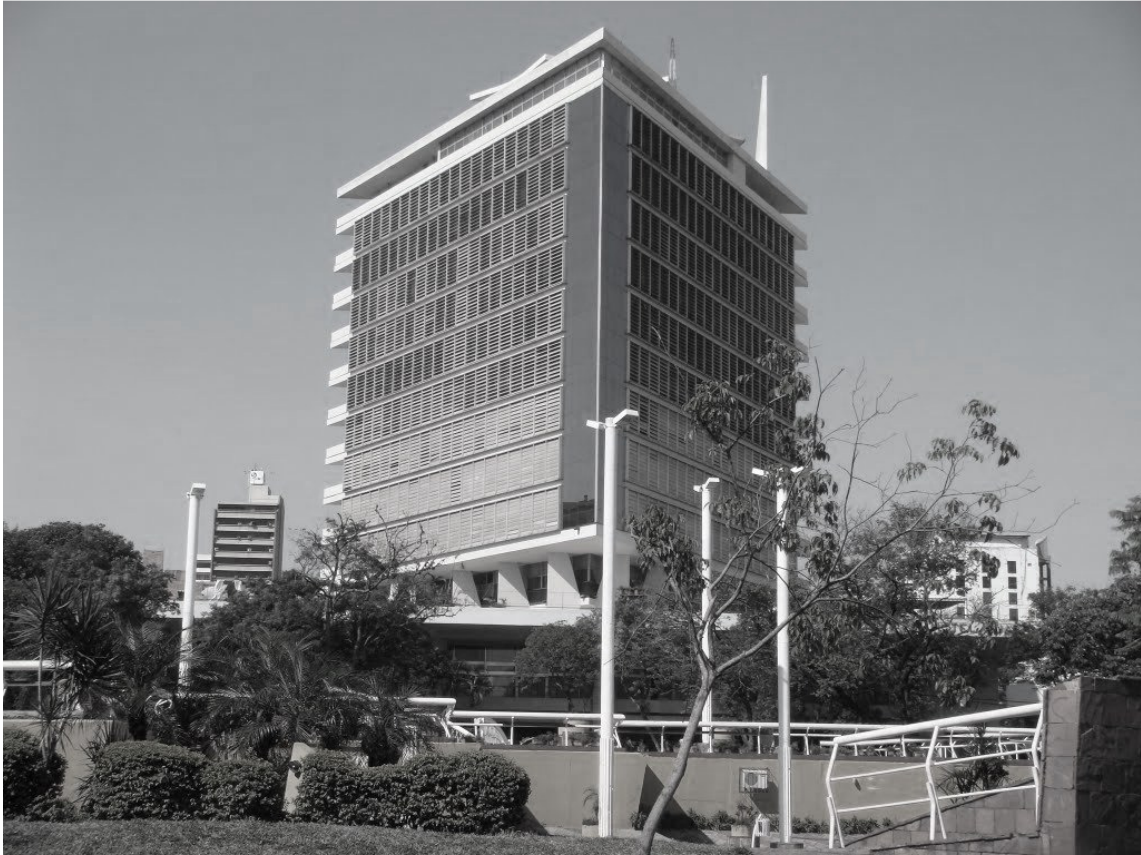
Fig. 6 Hotel Guaraní - Sight from Plaza de la Democracia

WA: Since the building has four different “deck layers” the stiffening in elevation is discontinuous so the value is assigned to 2. The second layer acts as a “neck”, upon which the triangular prism of the set rests.
